# **Monitoring Report for the Northern Pike Containment System at the Outlet of Lake Davis on Big Grizzly Creek**

Prepared for  
**Department of Fish & Game**

Prepared by  
Fish Passage Improvement Program  
**Division of Planning and Local Assistance**  
**Department of Water Resources**  
**June 2007**

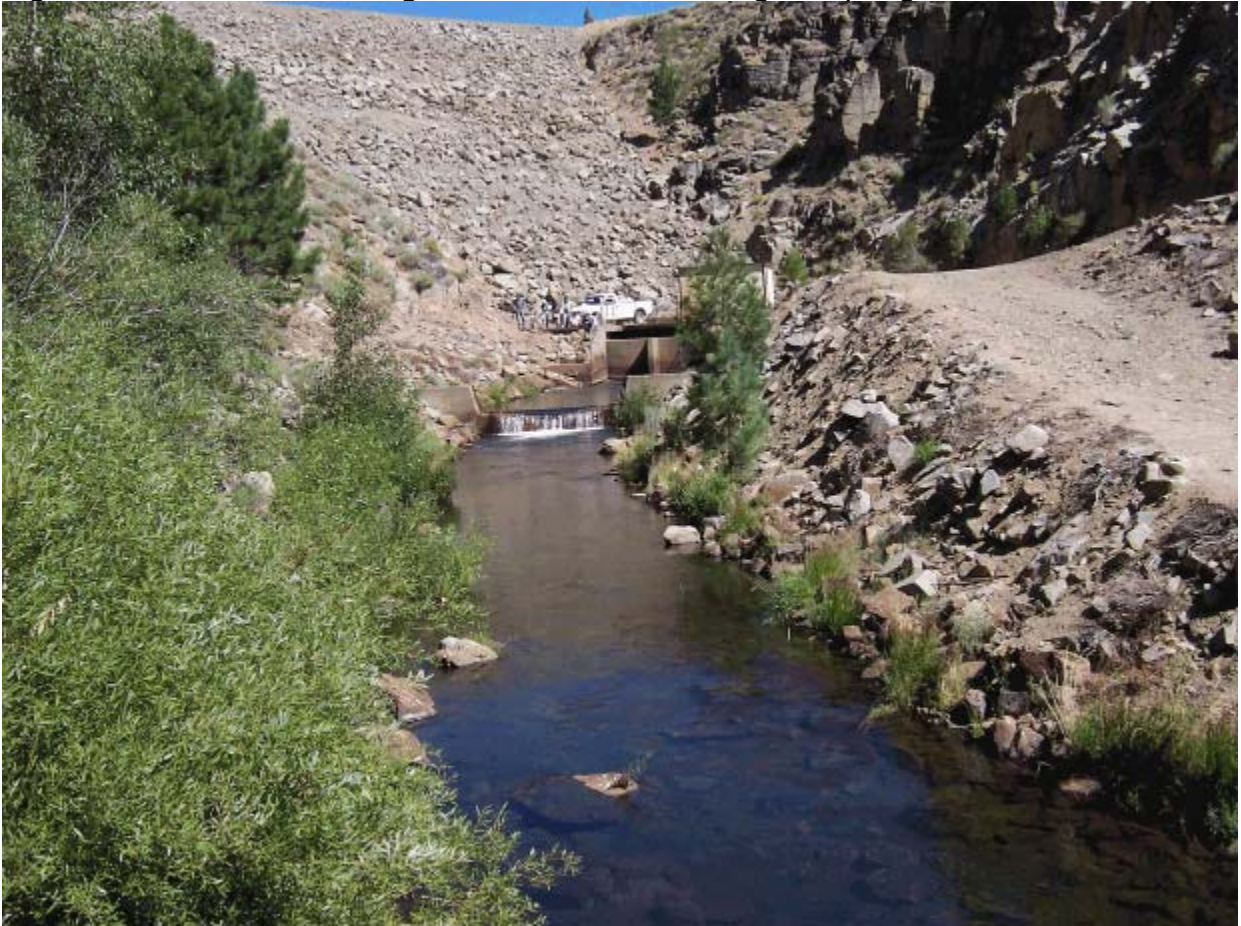
Figure 2. Left bank to be vegetated with willow cuttings in spring 2007

The project's mitigation and monitoring compliance agreement included planting of local willow cuttings downstream of the Cipolletti Weir (even though no willows were actually removed by the project) and replacement of one Ponderosa pine at a 1:1 ratio (DWR 2006). Locally-obtained willow cuttings were planted along the left bank of Big Grizzly Creek from the weir to the pedestrian bridge on Big Grizzly Creek (Figure 2). This work was also identified as fulfilling the compensatory mitigation for the ACOE Section 404 permit.

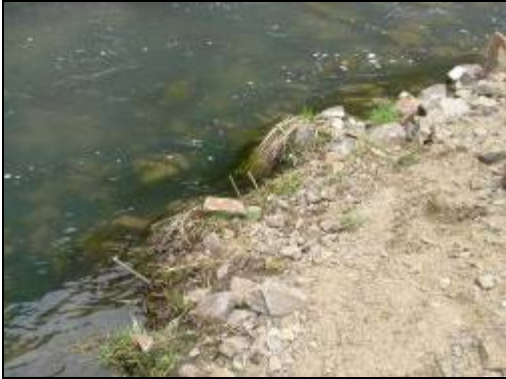
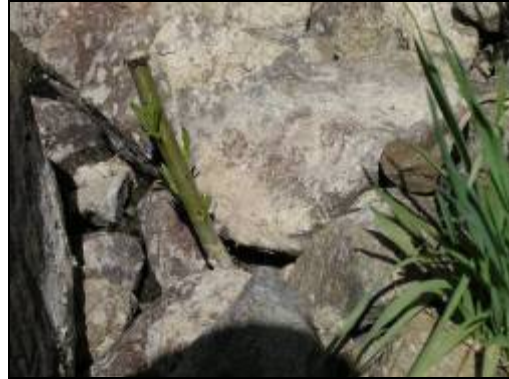
Figure 3. Local willow cuttings planted April 5, 2007 (left photo) and leafing out on May 14, 2007 (right photo).

On April 5, 2007, after most of the winter snow had melted, DWR staff planted 40 local willow cuttings along the left bank of Big Grizzly Creek, at the water's edge (Figure 3), and ten two-year old Ponderosa pine seedlings were planted on the right and left banks above Big Grizzly Creek (Figure 4).

A DWR botanist assessed the status of the planted material on May 14, 2007. There appeared to be 100% willow cutting survival, although only a few had leafed out at the time of the visit (Figure 3), and 100% Ponderosa pine survival (Figure 4), and all plants appeared to be healthy. DWR will periodically check the progress during summer 2007 and will replant willows if necessary in fall 2007.
